Quality Assurance and Source Inspection

Contract #: 04-0120F4Cty: SF/ALA Rte: 80 PM: 13.2/13.9File #: 69.28**WELDING INSPECTION REPORT****Resident Engineer:**Siegenthaler, Peter**Address:** 333 Burma Road**City:** Oakland, CA 94607**Report No:** WIR-020143**Date Inspected:** 23-Dec-2010**Project Name:** SAS Superstructure**OSM Arrival Time:** 1500**Prime Contractor:** American Bridge/Fluor Enterprises, a JV**OSM Departure Time:** 300**Contractor:** Zhenhua Port Machinery Company, Ltd (ZPMC), Changxing Island **Location:** Shanghai, China**CWI Name:** Mr. Yu Jiao (ABF)**CWI Present:** Yes No**Inspected CWI report:** Yes No N/A**Rod Oven in Use:** Yes No N/A**Electrode to specification:** Yes No N/A**Weld Procedures Followed:** Yes No N/A**Qualified Welders:** Yes No N/A**Verified Joint Fit-up:** Yes No N/A**Approved Drawings:** Yes No N/A**Approved WPS:** Yes No N/A**Delayed / Cancelled:** Yes No N/A**Bridge No:** 34-0006**Component:** BAY 14 OBG**Summary of Items Observed:**

OBG BAY 14

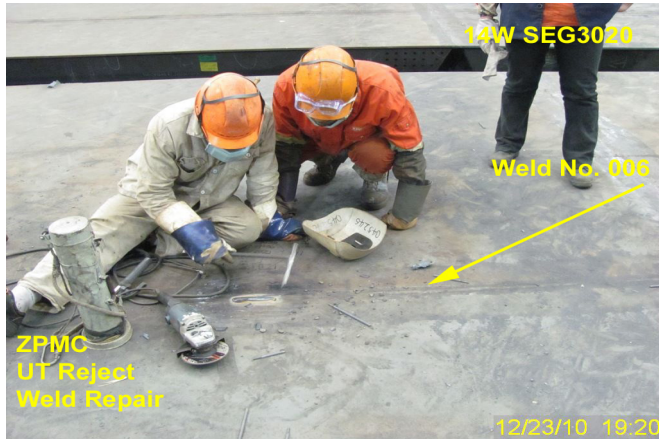
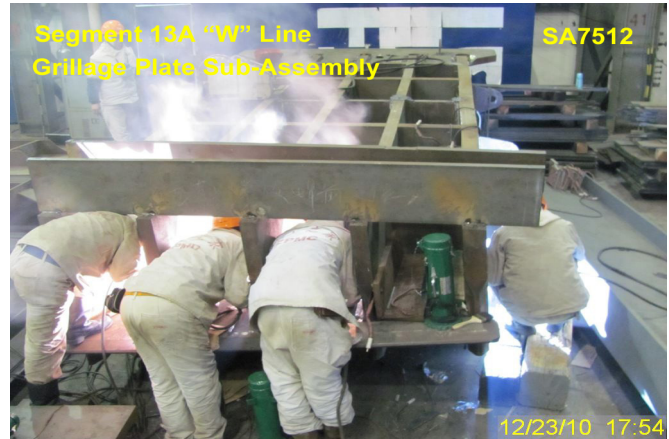
Please see attached photo

SMAW welding of complete joint penetration weld joint(s) located on Grillage Plate Sub-Assembly, Segment 13A "W" Line identified as SA7512 weld number(s) 021, 022, and 023. Welder is identified as welder no. 062708. The welding variables recorded by ZPMC QC identified as Li Ping appeared to comply with applicable WPS(s) WPS-B-P-2211-TC-U4b-FCM 1.

SMAW welding of complete joint penetration weld joint(s) located on Grillage Plate Sub-Assembly, Segment 13A "W" Line identified as SA7512 weld number(s) 024, 025, 026, and 027. Welder is identified as welder no. 045203. The welding variables recorded by ZPMC QC identified as Li Ping appeared to comply with applicable WPS(s) WPS-B-P-2211-TC-U4b-FCM 1.

FCAW welding of complete joint penetration weld joint(s) located on Grillage Plate Sub-Assembly, Segment 13A "E" Line identified as SA7038 weld number(s) 225 and 026. Welder is identified as welder no. 067079. The welding variables recorded by ZPMC QC identified as Zhong Yang Gang appeared to comply with applicable WPS(s) WPS-B-T-2231-ESAB.

During random in process inspection of Orthotropic Box Girder; (OBG) member identified as SEG3020* weld number(s) 004. This QA Inspector observed weld repair of complete joint penetration weld joint(s). ZPMC Quality Control personnel previously tested and rejected portions of this weld.

During random in process inspection of Orthotropic Box Girder; (OBG) member identified as SEG3020* weld number(s) 003. This QA Inspector observed weld repair of complete joint penetration weld joint(s). ZPMC Quality Control personnel previously tested and rejected portions of this weld.

During random in process inspection of Orthotropic Box Girder; (OBG) member identified as SEG3020* weld number(s) 006. This QA Inspector observed weld repair of complete joint penetration weld joint(s). ZPMC Quality Control personnel previously tested and rejected portions of this weld.
